# Arlington Memorial Bridge Repair & Reconstruction

**Project Description.** The condition of Arlington Memorial Bridge is degrading quickly. The Memorial Bridge has reached the end of its design life and requires extensive rehabilitation, to include full replacement of its center span. Corrective measures are needed now to keep the structure open to the public until the rehabilitation can be performed.

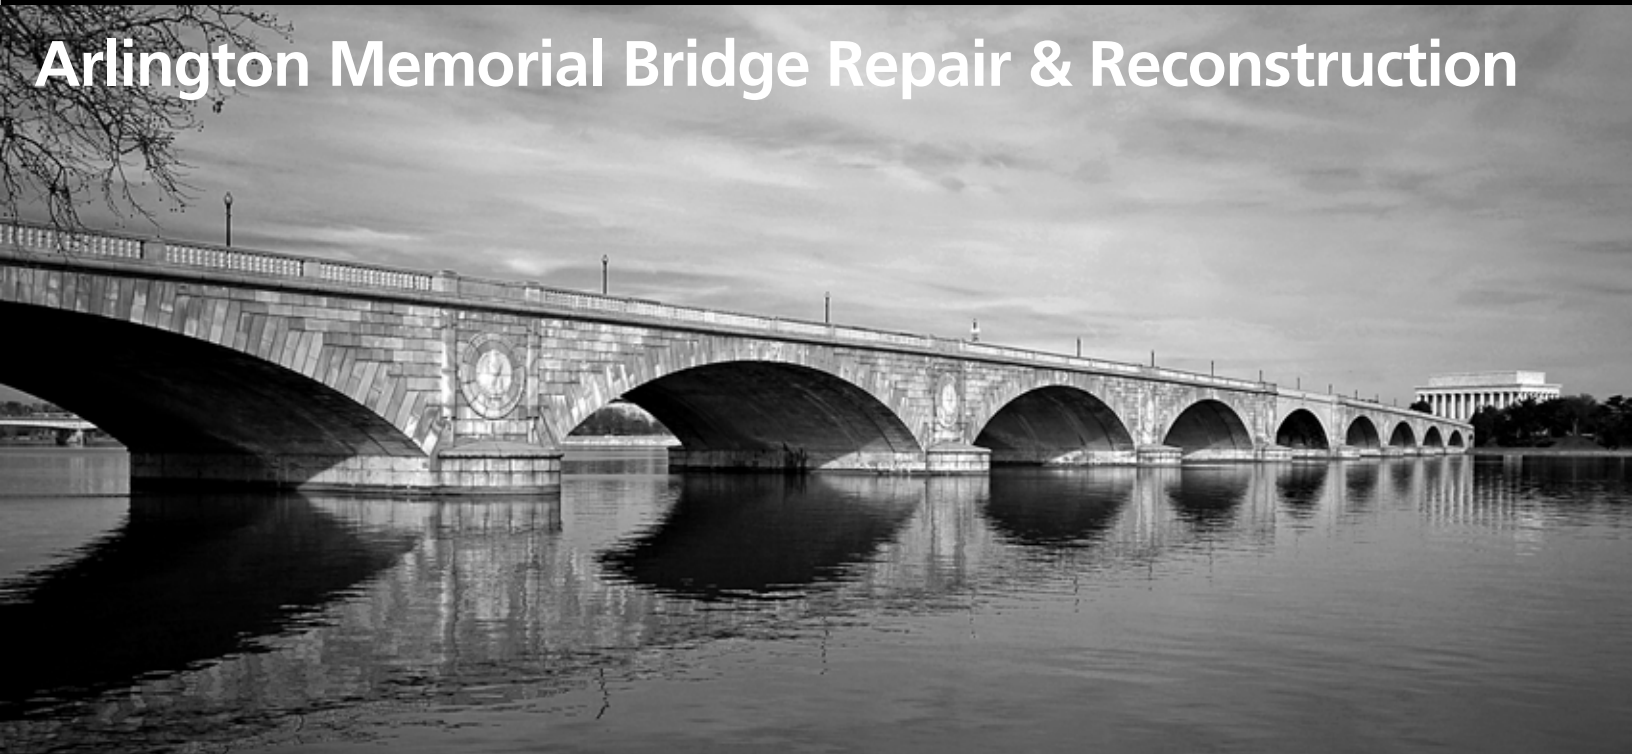
The Arlington Memorial Bridge linking Washington, DC, and Arlington, Virginia is in a serious state of deterioration. (Photo © Peter Tomlinson, [www.photosbypjt.com](http://www.photosbypjt.com))

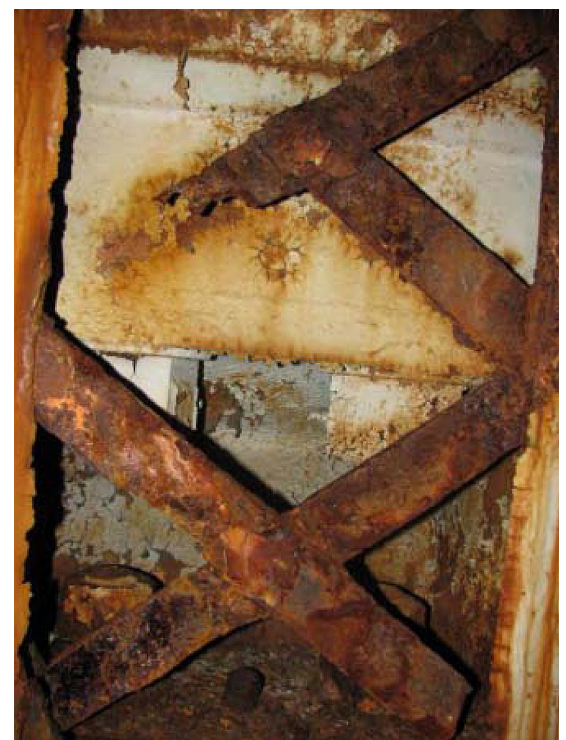
**Right: Rusting and section loss in an interior trunnion post for the north truss, west bascule leaf (NPS photo)**

The FHWA has recommended an additional interim project to shore up the bascule span's trunnion posts (the columns which hold up the center span) to guard against a partial failure. This is an example of the costly work necessary to keep the Memorial Bridge open and safe before the extensive rehabilitation work can even begin.

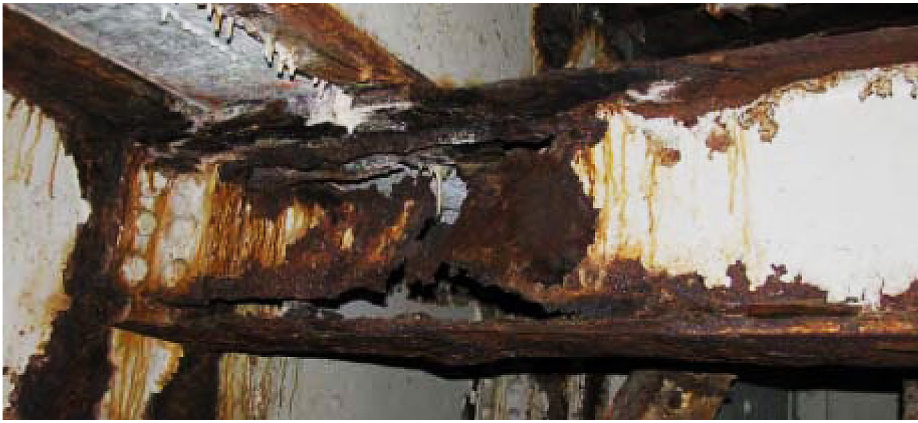
**Top: Section loss and rusting in stringers and framing for the north sidewalk at the east bascule abutment. (NPS photo)**

**Current Status:** The Memorial Bridge structure was listed as structurally deficient in its most recent biennial inspection. This is due primarily to severe corrosion of the steel in the bascule span; some support stringers and framing are missing altogether. In the event

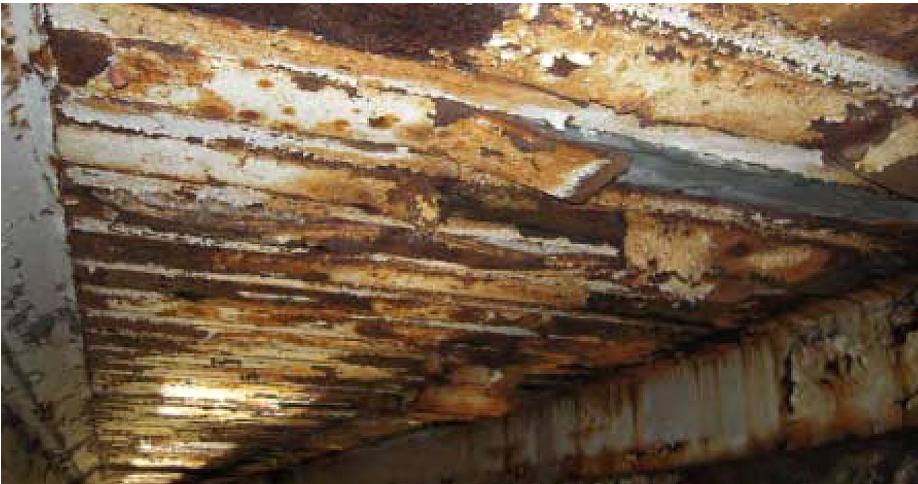
**Bottom: Typical rusting of the steel deck grid underside in the bascule span; this photo was taken at the bridge's mid-span. (NPS photo)**

- replacement of the steel draw span (bascule span);
- repairs to deteriorated portions of the abutments, piers, and concrete approach spans;
- replacement of the concrete bridge deck;
- repair or replacement of all the other systems that make it a safe, functional bridge, including: lighting, drainage, pedestrian access, and safety features.
